THAMES RIVER BASIN **DUDLEY, MASSACHUSETTS**

SOUTH VILLAGE DAM MA 00107

PHASE I INSPECTION REPORT NATIONAL DAM INSPECTION PROGRAM

NOVEMBER 1979

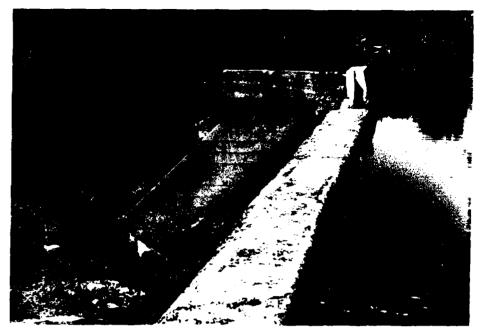
- (7) The stone masonry wall on the shore side of the canal has some stones missing and vegetation growing in the joints.
- (8) The concrete canal wall and overflow spillway have minor spalls along its length and a major face spall on the right side wall of the overflow spillway. A diagonal crack was

noted near the base of the overflow spillway right side wall. Vertical joints in these walls have started to deteriorate and some vegetation is present.

8. RIGHT STDEWALL OF CANAL SPILLWAY.

- (1) Remove the remaining flashboard pins from the overflow section of the dam.
- (2) Perform maintenance work on the concrete at the dam and canal. This should include the removal of vegetation from expansion joints, the sealing of expansion joints, the patching of spalls and cracks, and the resurfacing of the eroded concrete areas.
